**Subject: Removal Action Report
Dead Creek Sediment Removal Site
Sauget, St. Clair County, Illinois
EPA Contract No. 68-W-00-129
TDD No. S05-0104-010**

REMOVAL ACTION REPORT
DEAD CREEK SEDIMENT REMOVAL
SAUGET, ST. CLAIR COUNTY, ILLINOIS

**REMOVAL ACTION REPORT
DEAD CREEK SEDIMENT REMOVAL
SAUGET, ST. CLAIR COUNTY, ILLINOIS**

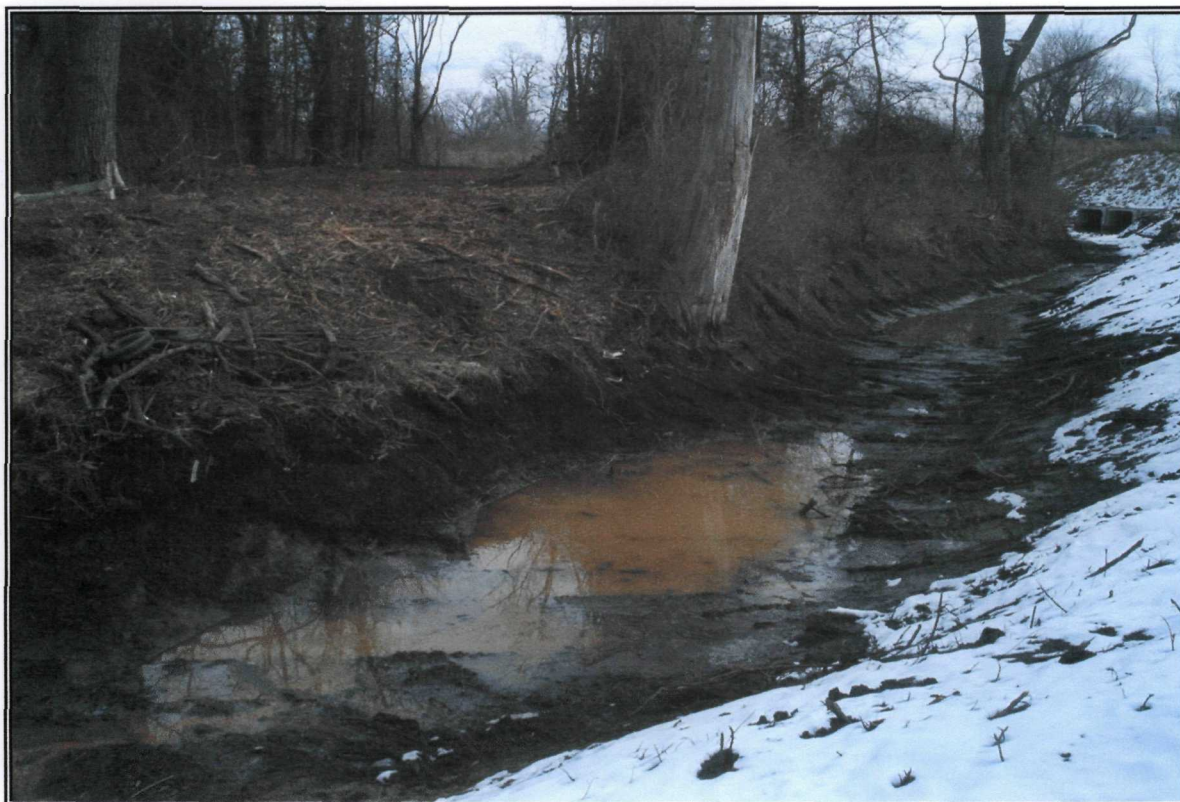
OFFICIAL PHOTOGRAPH NO. 51
U.S. ENVIRONMENTAL PROTECTION AGENCY

Subject: Discolored water in Segment F upstream from the dogleg.

I mentioned discussion with Rich that
Iron may be cause of discoloration.

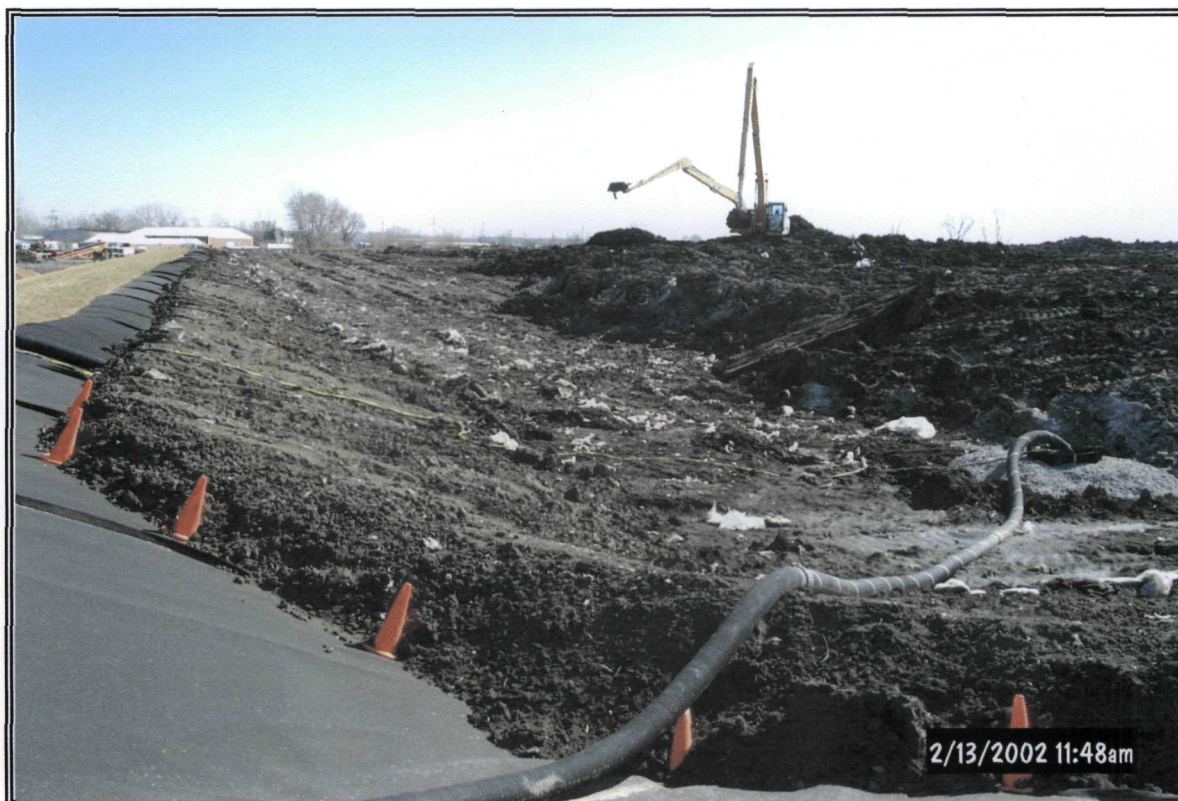
OFFICIAL PHOTOGRAPH NO. 53
U.S. ENVIRONMENTAL PROTECTION AGENCY

Subject: Northwest corner of cell showing the top of the sump and the discharge hose.

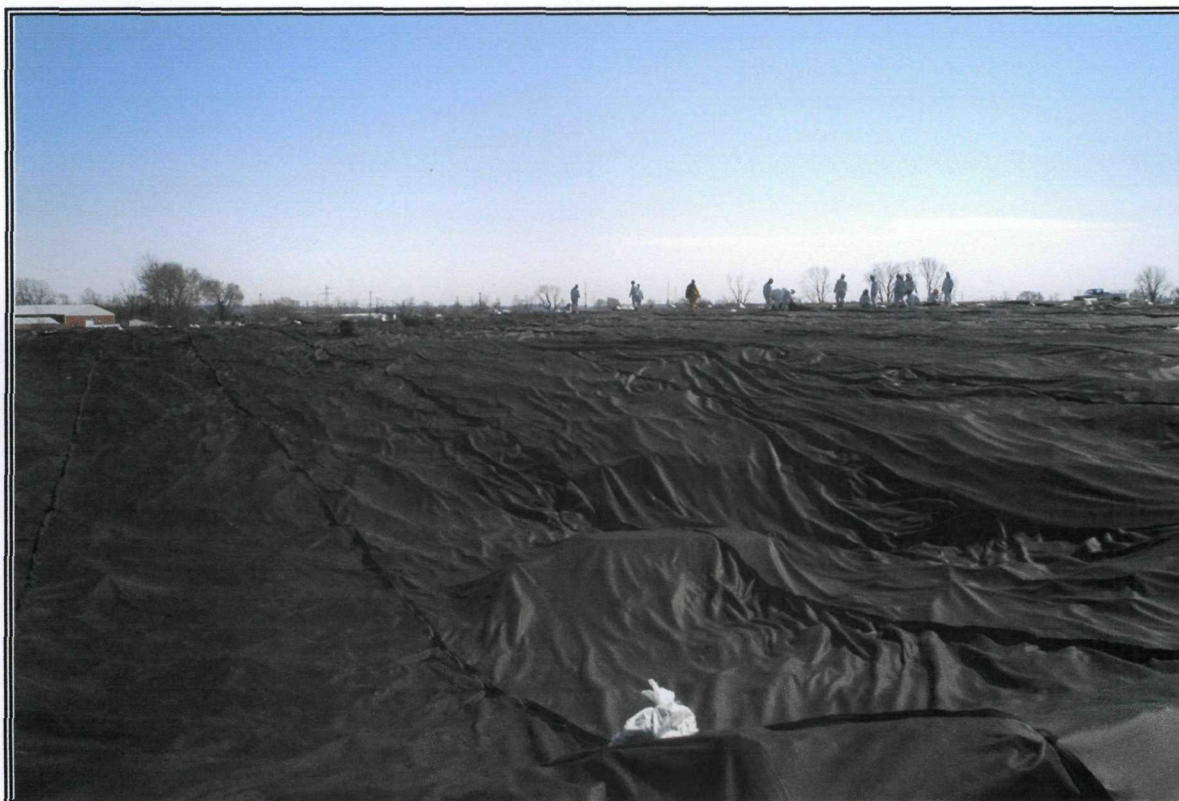
OFFICIAL PHOTOGRAPH NO. 54
U.S. ENVIRONMENTAL PROTECTION AGENCY

Subject: Placing the geomembrane cover over the sediment.

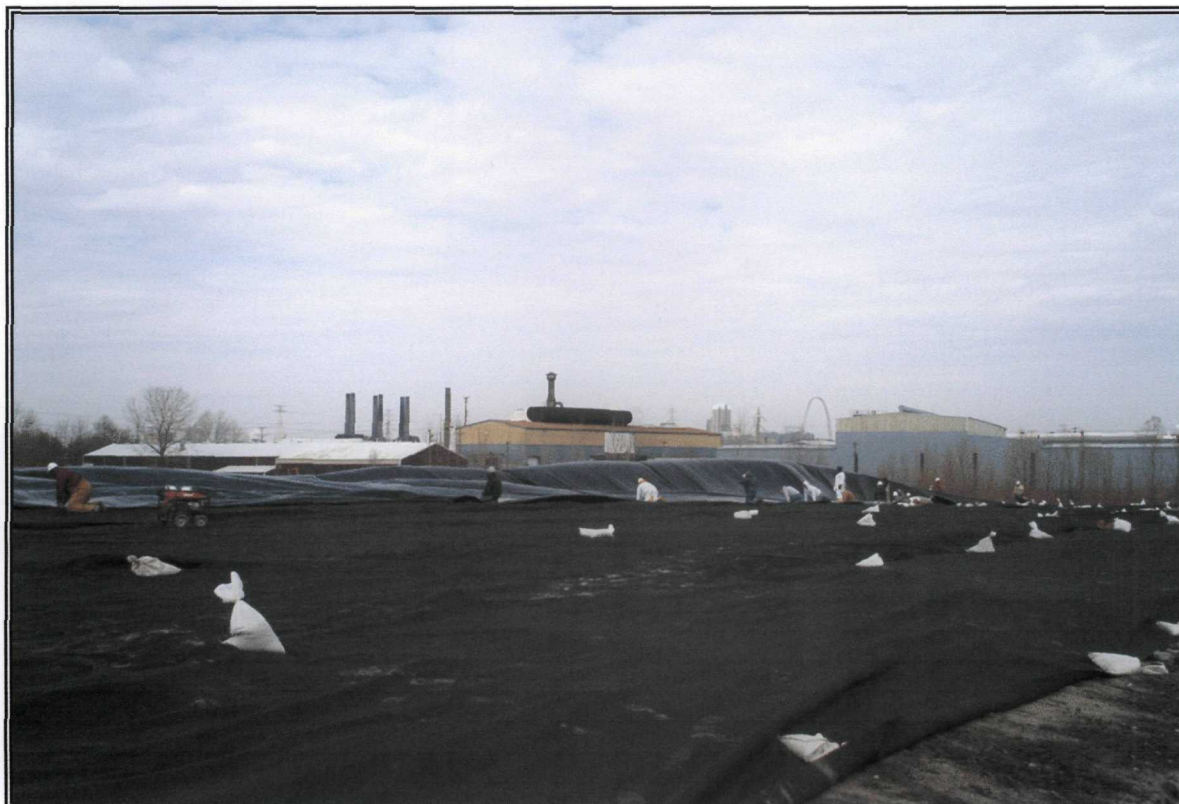
OFFICIAL PHOTOGRAPH NO. 55
U.S. ENVIRONMENTAL PROTECTION AGENCY

Subject: Placing poly over the geomembrane layer in the temporary cover.
